OSA -1293-67

Subject: OXYGEN RESTRICTION IN AIRPLANE 130

14 March 1967, aircraft #130

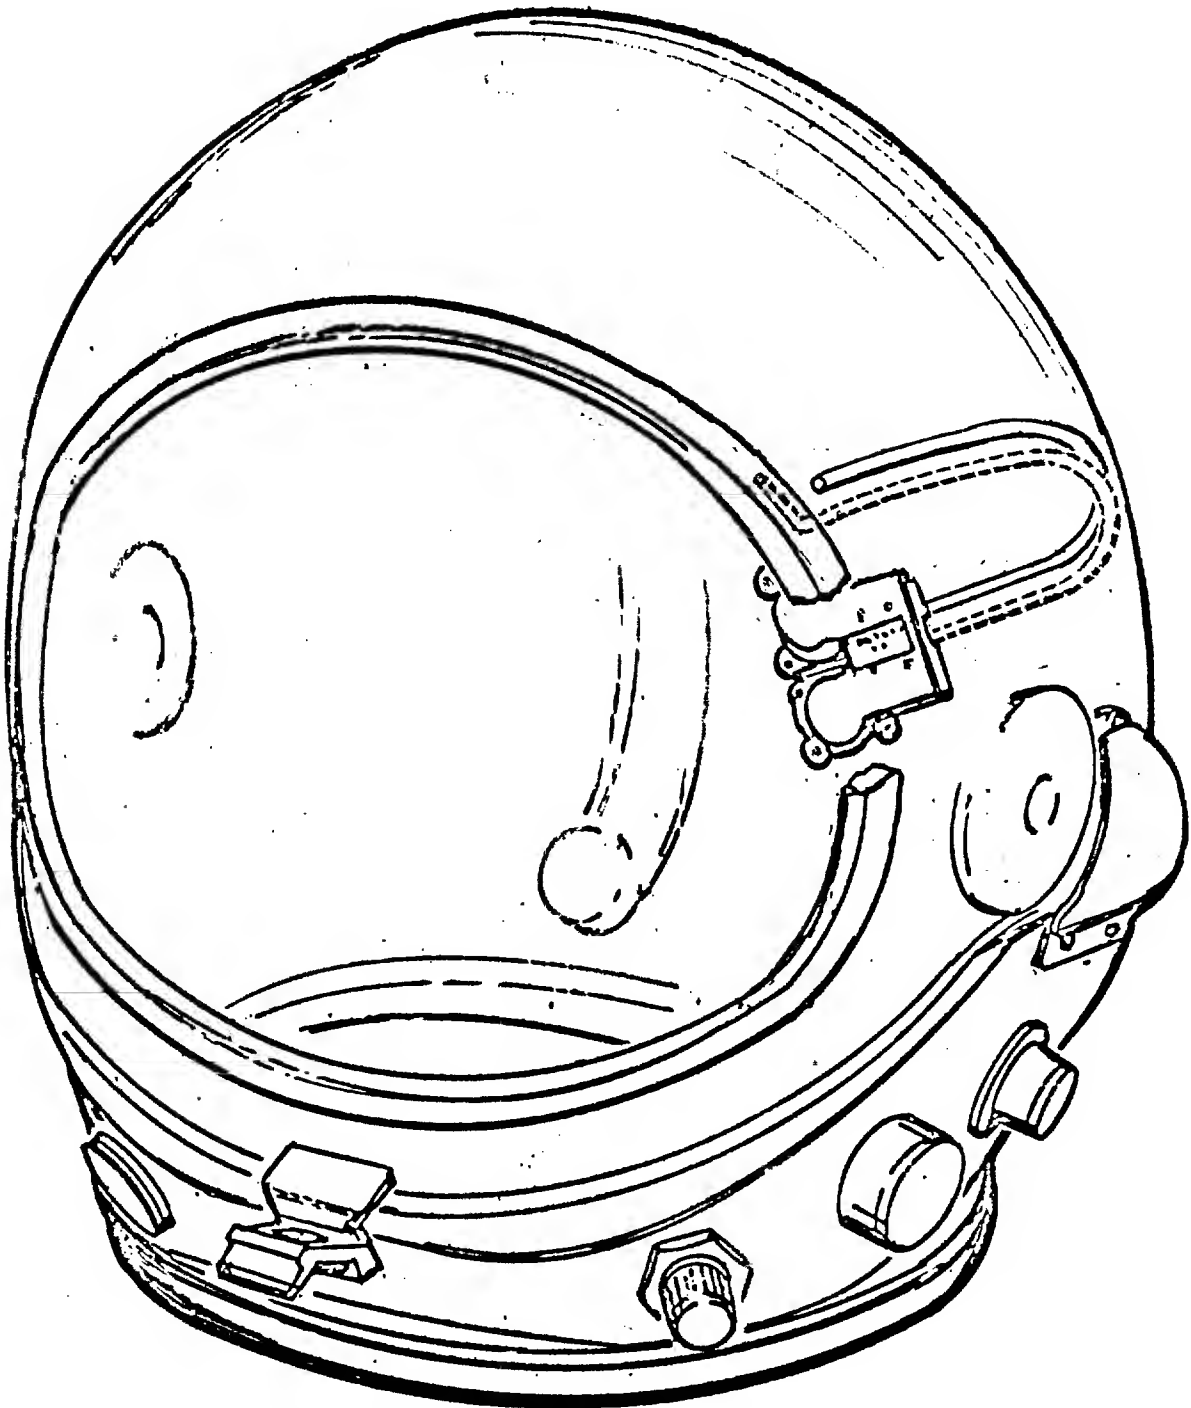
SINGLE OXYGEN DEMAND AND SENSE LINES

We are also experiencing another kind of trouble with these pressure reference sense lines at Beale in that entrapped condensate or sweat is permitted to run down into the regulators. The attached sketch shows this present installation - note that the line is downhill so that any moisture or foreign object would go down the tube into both of the regulators.

PRESENT SINGLE .38 OR .19 DIA.

SENSE LINE; PERMITS MOISTURE
TO ENTER REGULATOR
